Recommendation paper

Title: Change to Bird Scaring Lines (TL and FAA) material (all licences)

Date: 6 July 2020

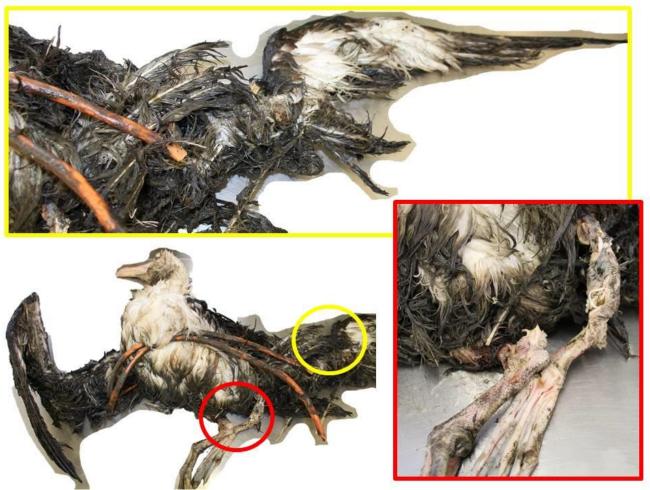
- 2.1. Data collected aboard trawlers indicate the use of orange flexible material continue and presents a real hazard for seabirds.
- 2.2. The use of orange flexible material revealed to be particularly counterproductive in the FAA (Fig.1).

Fig.1. Black-browed albatross mortality as result of entanglement in orange flexible streamer. Note the carcass is wrapped by the streamer and covered by warp cable grease. Exposed fracture of the left wing is highlighted in yellow, while fractures in both legs are highlighted in red.

- 3.1. It is recommended for BSL (TL & FAA) to have mandatory use of **double streamers made of semi-flexible red material**, *recommending* Red Mazzerpur 10 mm polyurethane tubing.
- 3.2. This measure is to improve BSL efficiency and maintenance, and will decrease seabird mortality related to streamer entanglements.
- 3.3. This recommendation is adopted into Fishing License Conditions from 1st January 2021
